Service Alert

APPLE CARPLAY™ / ANDROID AUTO™ FREQUENTLY ASKED QUESTIONS (FAQ)

Service Alert No.: SA-070/20

Last Issued: 10/15/2020

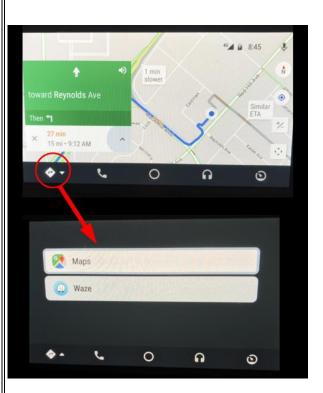
When using the steering wheel Voice Command button to set a navigation destination, Android Auto™ defaults to the last navigation app that was used. Select the "Maps and Navigation" icon to set your default navigation app.

Android Auto™: The wrong navigation app opens when using the steering wheel Voice Command button.

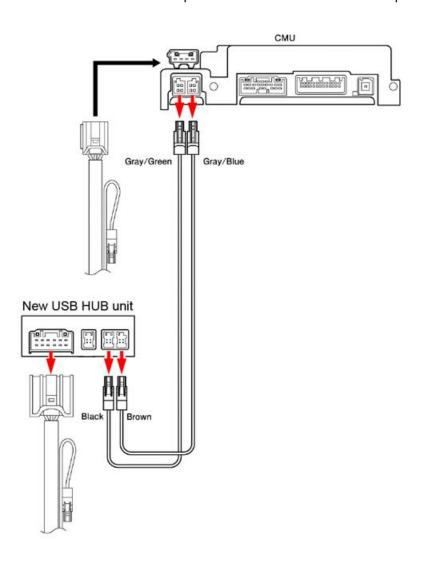
This may be caused by smart phone Cable Set Kit (P/N C922-V6-605) installation error. The hardware was installed before CMU software update by smart phone flash drive.

Failure: In some cases, the CMU will not recognize the new HUB unit, so CMU software update by smart phone flash drive is not possible.

(Cannot install CMU software after smart phone Cable Set Kit (P/N C922-V6-605) installation)

1. Disconnect the new smart phone HUB unit and the new smart phone cables from the CMU.
